64-bit Intel[®] Xeon[®] Processor with 800 MHz System Bus (1 MB and 2 MB L2 Cache Versions)

Specification Update

June 2006

Document Number: 302402-022

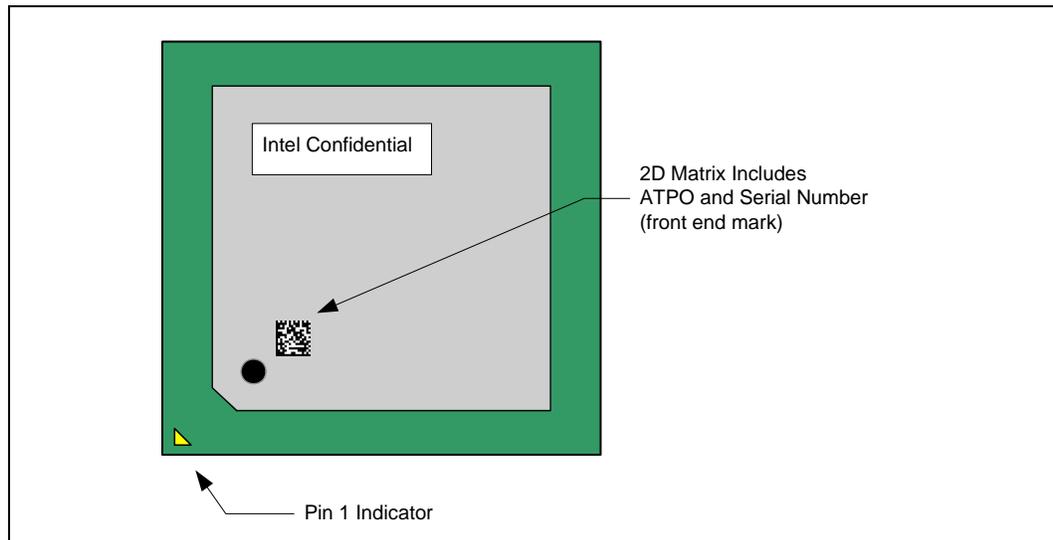
Figure 1. Top-Side Processor Marking Example

64-bit Intel® Xeon® Processor with 800 MHz System Bus (1 MB and 2 MB L2 Cache Versions) Package Markings (604-pin FC-mPGA4 Package)
